GROUNDWATER QUALITY OF SPRING KRKA IN GROUNDWATER BODY DOLENJSKI KRAS (SLOVENIA)

M. Gacin¹, M. Dobnikar - Tehovnik², P. Mihorko³

1,2,3 Slovenian Environment Agency, Vojkova 1b, 1000 Ljubljana, marina.gacin@gov.si, mojca.dobnikar-tehovnik@gov.si, polonca.mihorko@gov.si

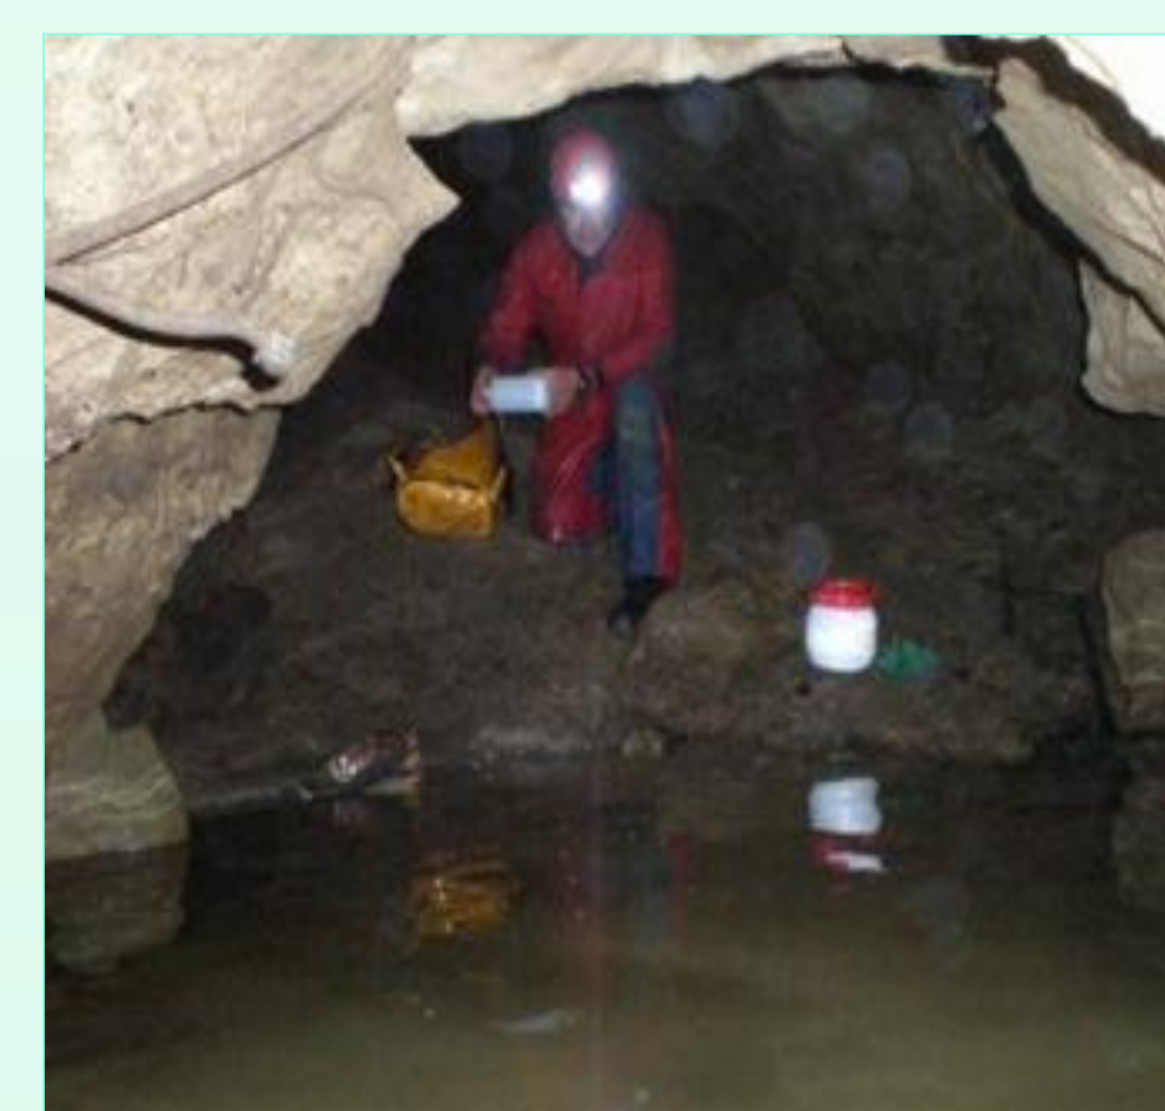
Figure 2. Catchment area of spring Krka with caves and shafts which are often waste dumps

Catchment area of spring Krka is situated SE from Grosuplje (Petrič, 2007). It is forest area with many caves and shafts which are often used as illegal waste dumps (Fig. 2) (Čekada, 2011). Due to the suspicion of bigger pollution in this area Speleological Association of Slovenia was engaged to check and clean 53 caves.
